1 2 3 4 5 6 7	Christina C. Sharp (State Bar No. 245869) Jordan Elias (State Bar No. 228731) Adam E. Polk (State Bar No. 273000) GIRARD SHARP LLP 601 California Street, Suite 1400 San Francisco, CA 94108 Tel: (415) 981-4800 Fax: (415) 981-4846 dsharp@girardsharp.com jelias@girardsharp.com apolk@girardsharp.com  Eric H. Gibbs (State Bar No. 178658)						
8	Dylan Hughes (State Bar No. 209113) Steven M. Tindall (State Bar No. 187862)						
9	Amy M. Zeman (State Bar No. 273100) GIBBS LAW GROUP LLP						
10	505 14th Street, Suite 1110 Oakland, CA 94612						
11	Tel: (510) 350-9700 Fax: (510) 350-9701						
12	ehg@classlawgroup.com dsh@classlawgroup.com						
13	smt@classlawgroup.com amz@classlawgroup.com						
14							
15	Plaintiffs' counsel						
16 17	UNITED STATES DISTRICT COURT NORTHERN DISTRICT OF CALIFORNIA						
18							
1 ( )		Case No.					
19	V.A. and V.B.						
20	Plaintiffs,	Case No.  COMPLAINT AND DEMAND FOR JURY TRIAL

#### I. Tank 4: A Chart MVE Cryopreservation Tank

The Defect in Tank 4

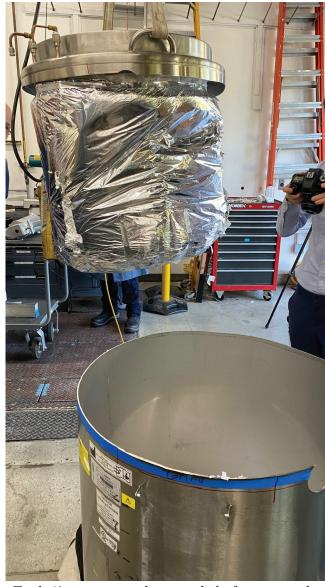
Tank 4's inner vessel suspended after removal from outer vessel (vacuum space was in between)

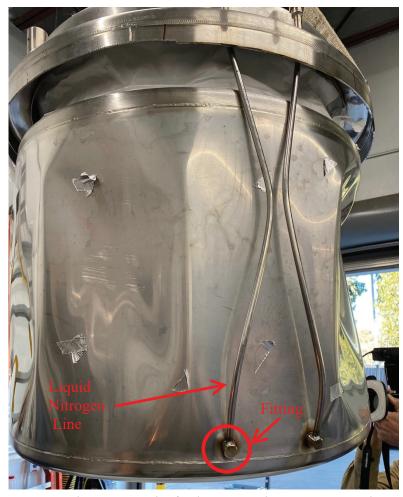
- 23. Tank 4 was only six years old when its vacuum insulation suddenly failed. The reason for the failure was a defective weld near the bottom of the tank's inner vessel.
- 24. Tank 4 was manufactured with a metal tube that is used to refill the tank with liquid nitrogen. The tube ran from the top of the tank, down through the vacuum space between the inner and outer vessel, and then into the inner vessel near the bottom of the tank.
- 25. The picture below was taken after the outer vessel of Tank 4 was removed. The liquid nitrogen tube is on the left and the red circle shows where it connects to the inner vessel through a fitting.

Liquid nitrogen tube feeds into Tank 4's inner vessel

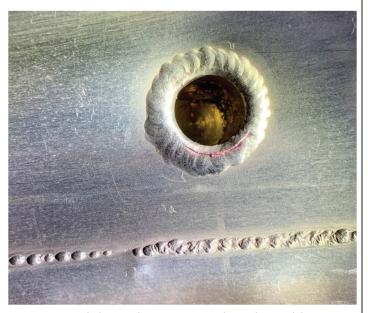
- 26. The fitting is held in place by a single weld on the inside of the inner vessel wall. That weld cracked, as shown in the images below. The image on the left was taken after application of Snoop Liquid Leak Detector. The bubbles indicate a leak. After multiple inspections of the tank by all interested parties, including leak testing by Chart, no other leak has been detected.
- 27. The image on the right is the same weld, this time after using Magnaflux Spotcheck liquid dye penetrant. The fact the red dye penetrant remained after the surface was wiped clean is indicative of a crack.

Red dye indicates a crack in the weld
